# Performance Oriented Guidance for Mississippi Chip Seals-Volume II

## Final Report

## FHWA/MS-DOT-RD-13-211-Volume II

Mississippi State University

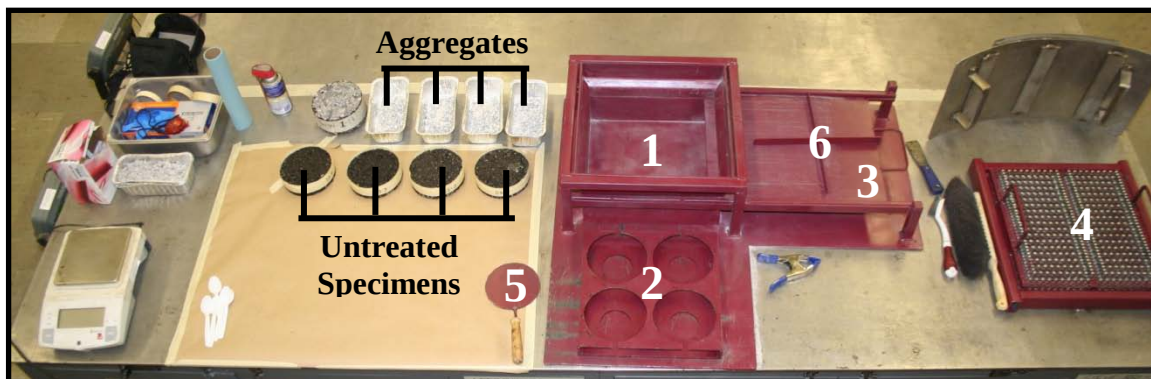
**Figure 4.1. Overall View of LTP Specimen Fabrication Assembly Line**

The LTP equipment used during laboratory specimen fabrication represents an assembly line that involves emulsion spread, aggregate spread, and chip seal surface seating (Figure 4.1). The equipment is capable of producing four chip seal circular specimens during each production cycle, or of producing one slab per production cycle that can be cored to produce two circular specimens. The fabrication assembly line equipment consists of six different assemblies, and each is described in the remainder of this section, while Figure 4.1 labels each of the six items to assist in understanding how they are used together.

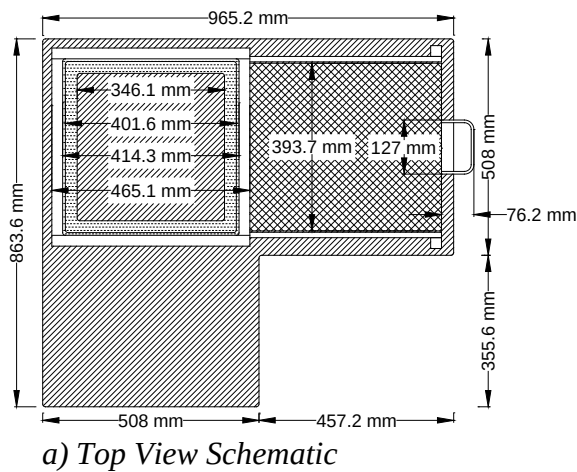
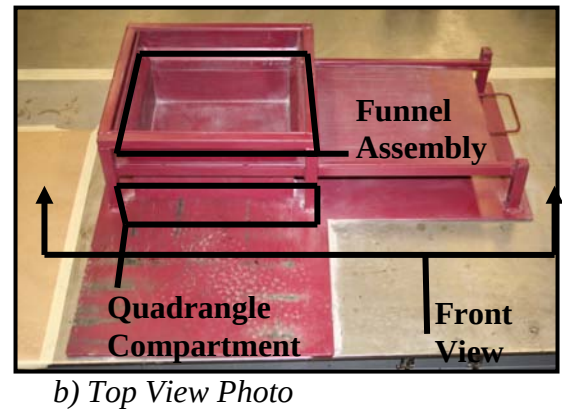
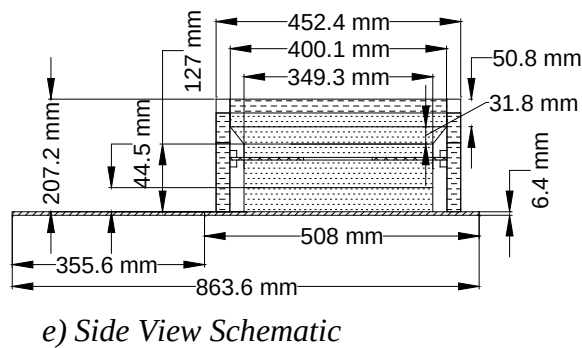
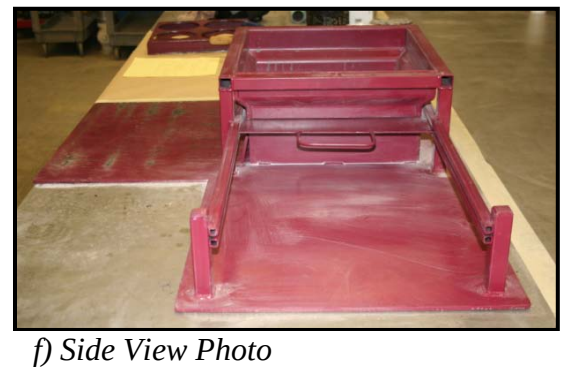
Figure 4.2. Spreader Base

The *Spreader Base* consists of multiple parts, compartments, and platforms (Figure 4.2). It is a funnel-shaped assembly which contains the *Specimen Box* during aggregate spreading (only when circular specimens are fabricated). The front of the spreader base serves as a platform where the *Specimen Box* is placed before and after aggregate spreading. The platform allows for smooth motion of the *Specimen Box* in and out of the assembly without disturbing LTP specimens. The platform connects to a quadrangle compartment located under the funnel assembly where aggregate is dropped. The funnel assembly and spreader sheet are positioned 90 mm from the bottom platform, directly above the quadrangle compartment where the *Specimen Box* is introduced. Rails enable lateral movement of the *Aggregate Spreader Sheet* through which aggregate is spread into the specimen box.

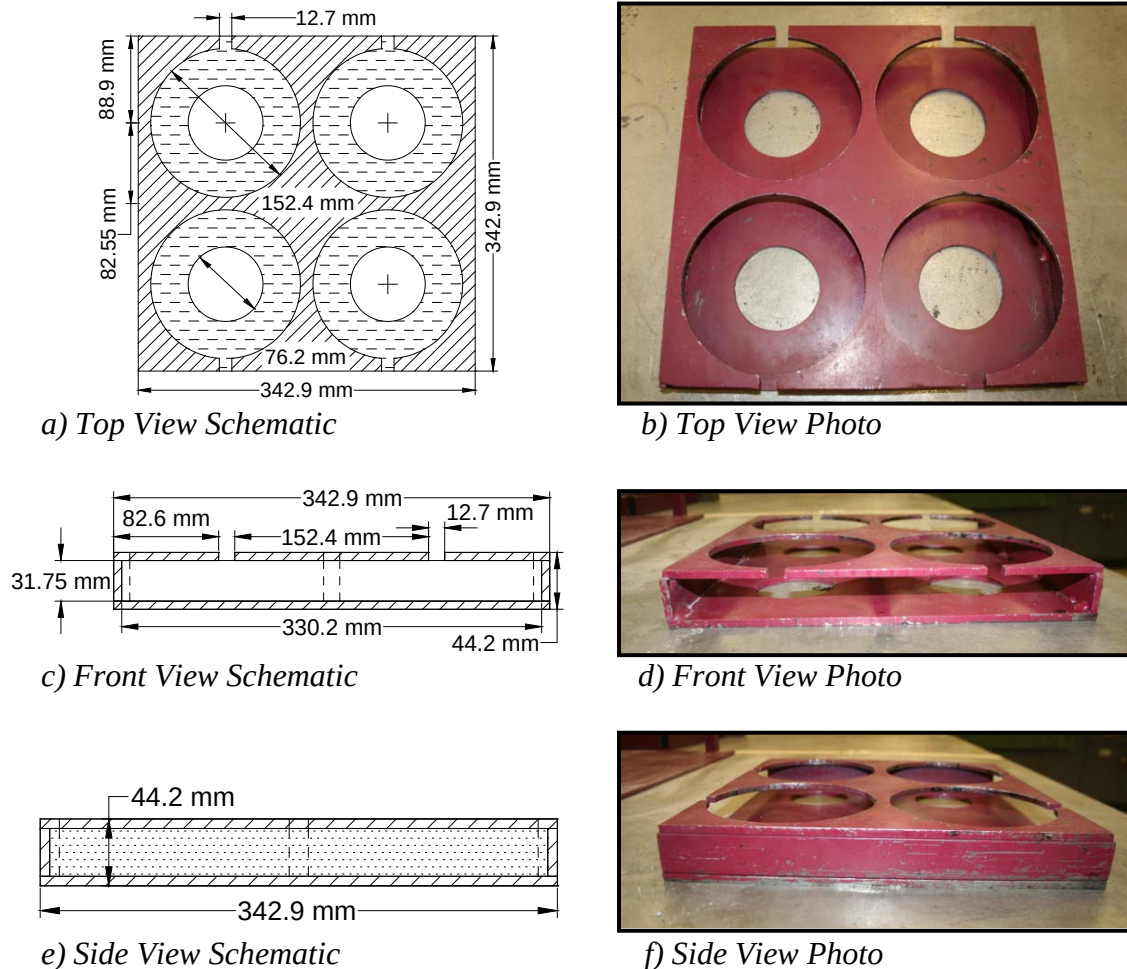
**Figure 4.3. Specimen Box**

The *Specimen Box* (Figure 4.3) has a main function of containing four compacted circular asphalt specimens during fabrication. It consists of multiple 6 mm plates welded into a 340 by 340 by 32 mm box. The upper plate of the box has four circular openings which hold specimens ready for aggregate application. Each opening contains a small slot to accommodate the *Specimen Panhandle* which facilitates insertion of each specimen into the box. The bottom plate has four 76 mm circular openings that enable specimen removal.

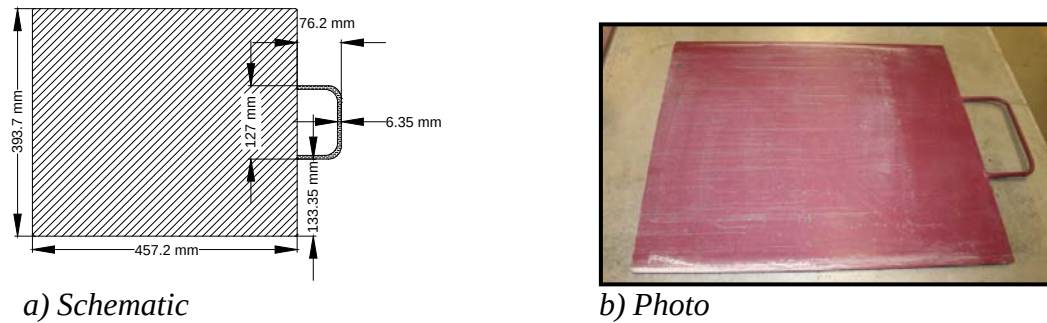
**Figure 4.4. Aggregate Spreader Sheet**

The *Aggregate Spreader Sheet* (Figure 4.4) serves two purposes: 1) retain aggregates in the funnel assembly prior to dropping and 2) drop aggregates onto the surface of compacted asphalt that has already had emulsion applied to its surface. The sheet has a handle on one side which enables lateral sliding in and out of the funnel assembly. The sheet allows aggregates to be placed in a manner representing construction.

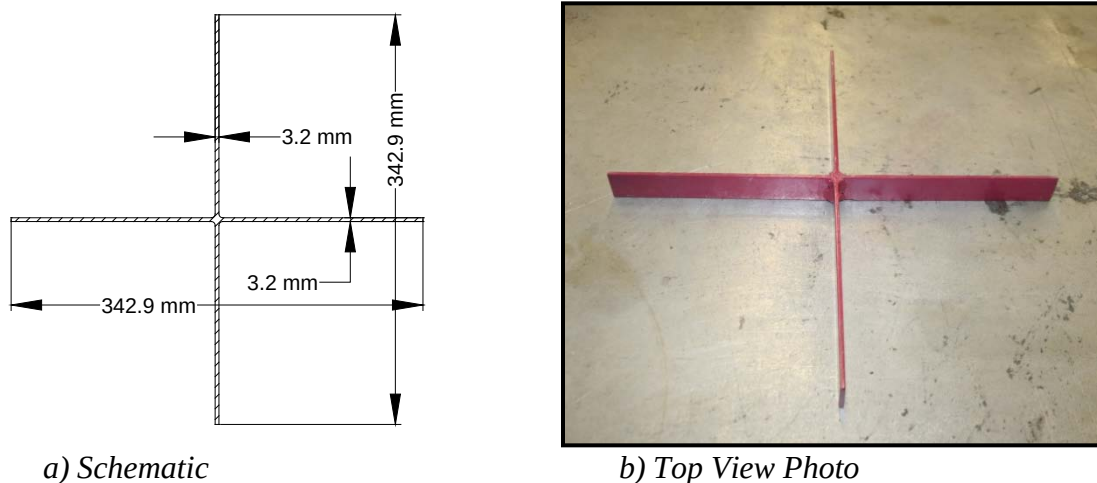
**Figure 4.5. Aggregate Divider**

The *Aggregate Divider* (Figure 4.5) is used to assist with uniformity during aggregate spreading. It consists of two 343 mm long by 25 mm wide by 3 mm thick steel shims welded at the center. It is placed on the *Aggregate Spreader Sheet* before aggregate is dropped and is removed before introducing the *Aggregate Restrainer*.

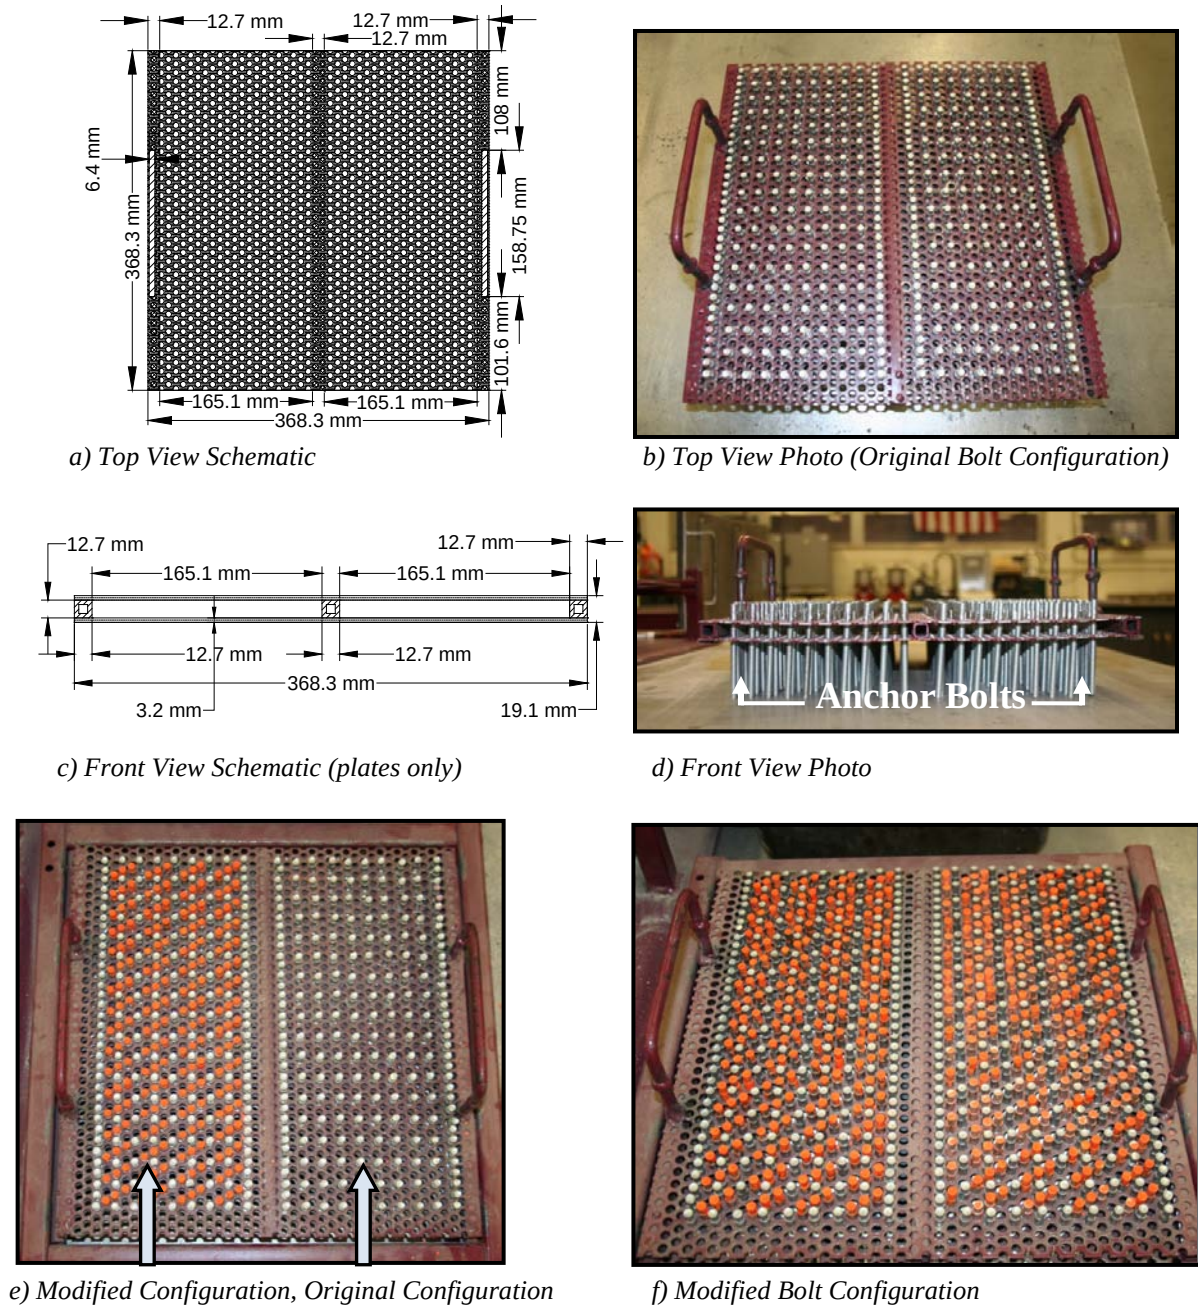
**Figure 4.6. Aggregate Restrainer**

It consists of two sets of two welded and perforated steel plates with slots for approximately 730 anchor bolts fully penetrating each set of two plates (Figure 4.6), providing spaces for approximately 1460 total anchor bolts. The perforated plates are spaced 6-mm from each other by three 6-mm thick steel channels, spaced evenly between both plates.

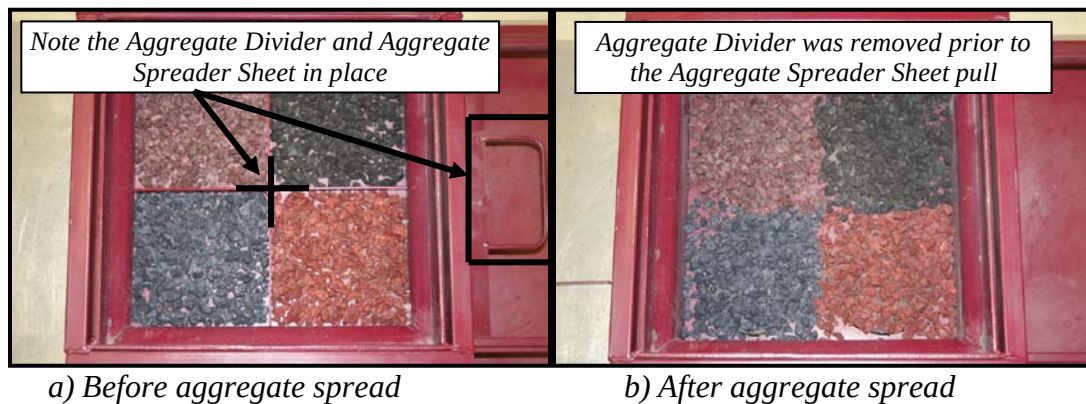
**Figure 4.7. Aggregate Restrainer Uniformity Experiment**

The aforementioned experiment was performed on aggregate on the order of Size 7, and with the *Aggregate Restrainer* containing around 400 anchor bolts as shown in Figure 4.6b. Seeing that aggregates dropped as desired in Figure 4.7, specimen fabrication commenced this anchor bolt pattern. Early fabrication attempts with Size 89 aggregates observed that the aggregate restrainer was not effective at holding material smaller than 2.36 to 4.75 mm in place during *Aggregate Spreader Sheet* pulling. To address this issue, the number of anchor bolts was increased by approximately 800, and placed in the configuration shown in Figure 4.6f. Anchor bolts applied in the modified configuration are painted orange, while the original configuration is silver.

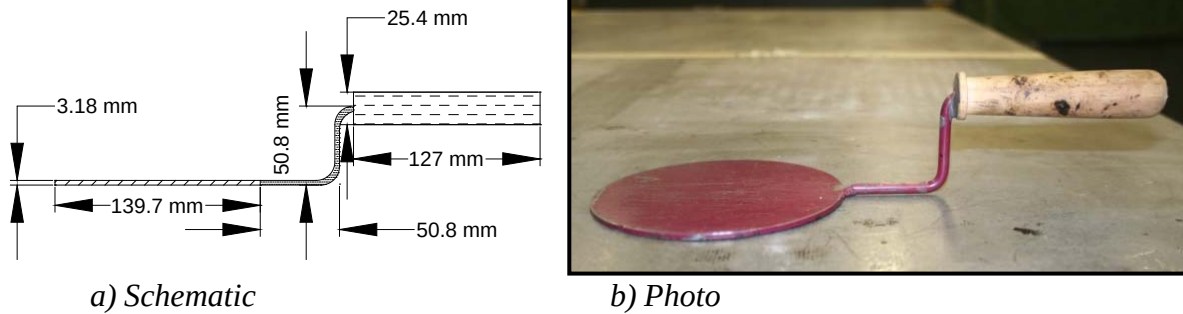
**Figure 4.8. Specimen Panhandle**

The *Specimen Panhandle* is used to transfer each individual circular specimen from the scale into the *Specimen Box* (Figure 4.8). Each specimen rests on the panhandle during emulsion application, and then is transferred into the box. When slabs are fabricated, the *Specimen Panhandle* is not used.

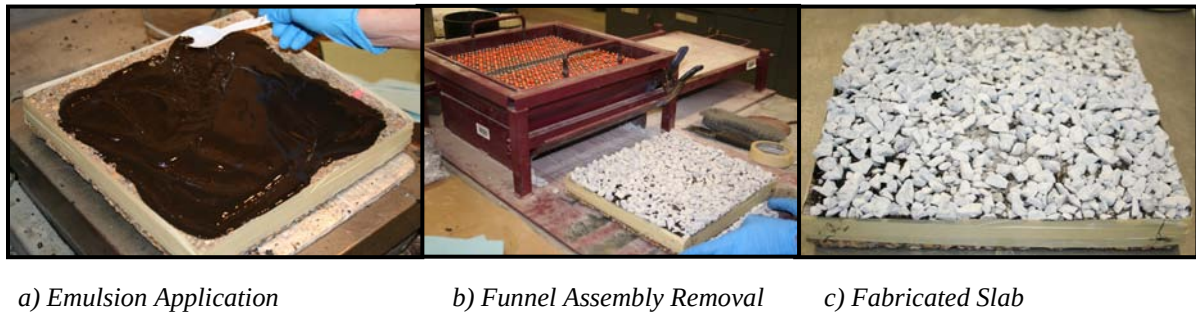
**Figure 4.11. Specimen Fabrication Procedure - Slabs**

Figure 4.11 demonstrates slab specimen fabrication. Emulsion application for slabs is identical to that of cores. Once emulsion is applied, the slab is inserted into the funnel assembly without the use of the *Specimen Box*. After aggregates are spread and the slab is removed from the funnel assembly, the surface is seated in the same manner as for core specimens. Once fabricated, slabs went through embedment and conditioning prior to having test specimens cored from the slabs. Generally speaking, two circular test specimens were cored from each slab.

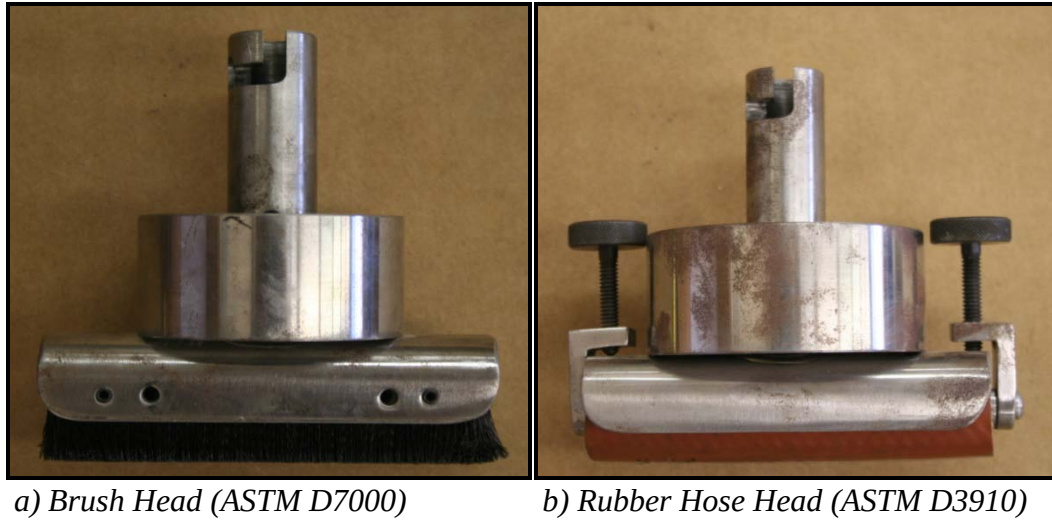
**Figure 4.15. Abrasion Heads**

Two abrasion heads were used with the LTP test (Figure 4.15). The brush head (ASTM D7000) and the rubber abrasion hose head (ASTM D3910) were used. Ultimately, the abrasion hose head (D3910) was selected for use as described later in this report.

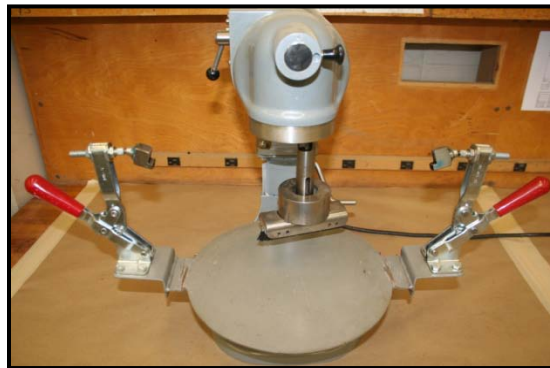
**Figure 4.16. Hobart N50 Mixer with Mounting Base in Place**

All testing was performed using the Hobart N50 planetary mixer which is discussed in detail in the State Study 211 Volume I report. The LTP abrasion test was conducted at mixer speed number 1. Figure 4.16 shows the Hobart N50 mixer with the sweep test mounting base and the Figure 4.15a brush head in place.

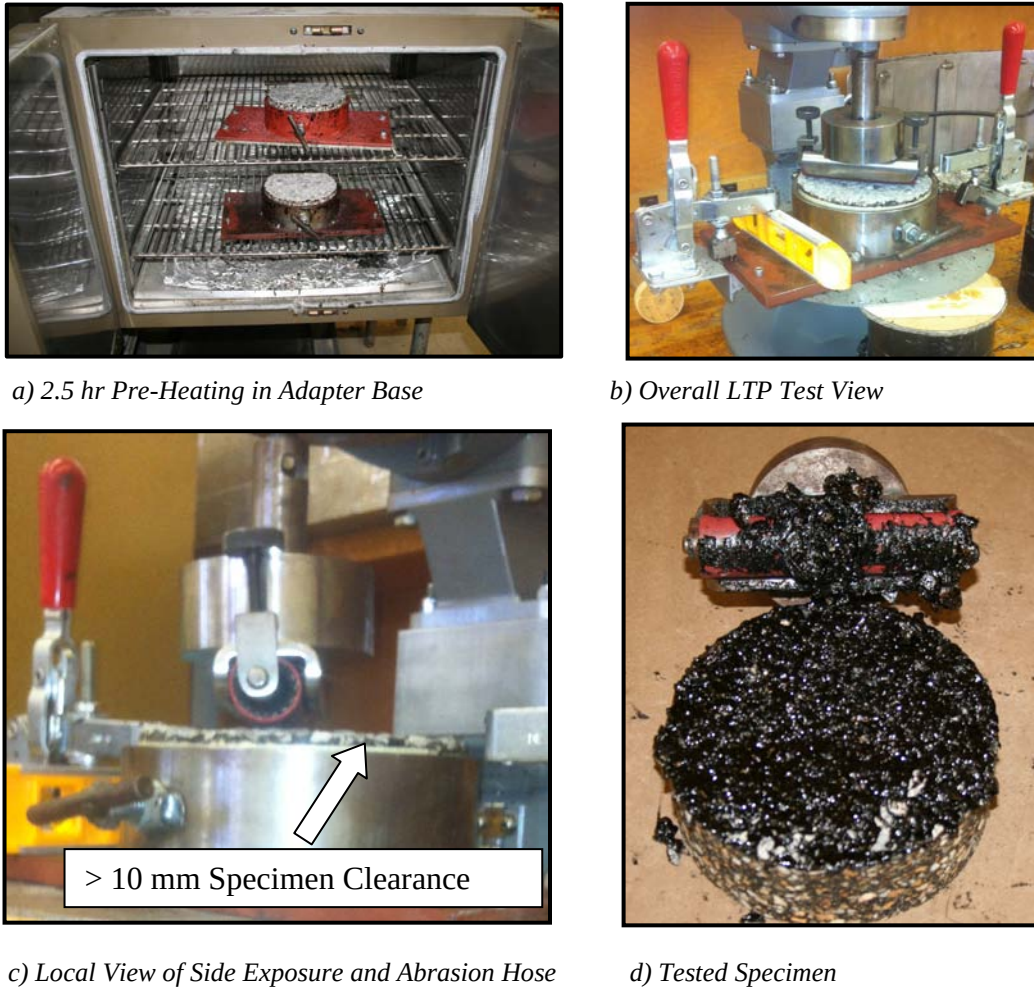
**Figure 4.18. LTP Specimen Testing**

In phase 1, specimens were pre-heated from room temperature 1 hr in an oven set at the test temperature absent the *Adapter Base*. After pre-heating, specimens were carefully secured in the room temperature *Adapter Base* in less than 30 seconds. Aluminum spacers of different thicknesses were placed on the bottom, inside of the steel ring to adjust the specimen height so that the chip seal application was at least 10 mm above the *Adapter Base* (Figure 4.18c is an example).

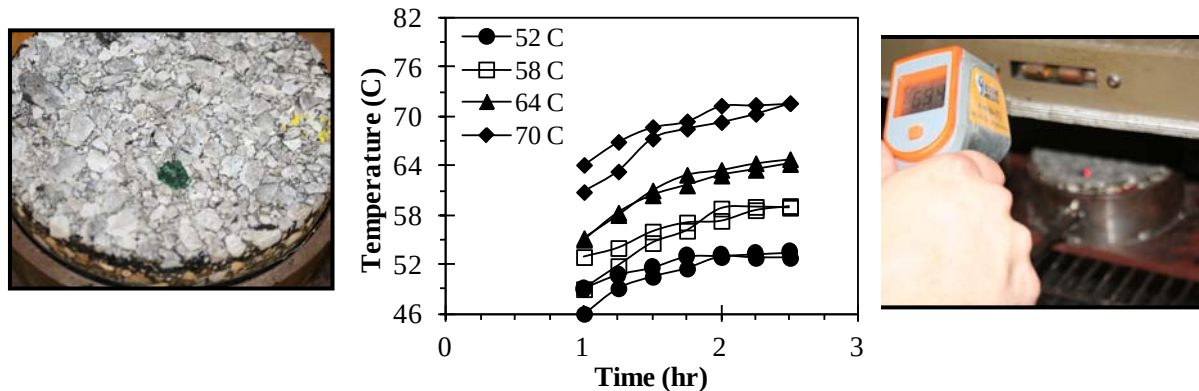
**Figure 4.19. Development of Pre-Heating Protocol**

base to be taken directly from the oven to the mixer for testing and minimization of heat loss. The time from opening the oven doors to commencing abrasive forces (T1) from the LTP test (Figure 4.18c) was generally 50 seconds or less (a 60 second or less tolerance is reasonable and was achieved for almost all cases in this project). T1 was the beginning of the LTP test. The final pre-heating configuration for phases 2 and 3 was 2.5 hours while pre-positioned in the *Adapter Base* (Figure 4.18a).

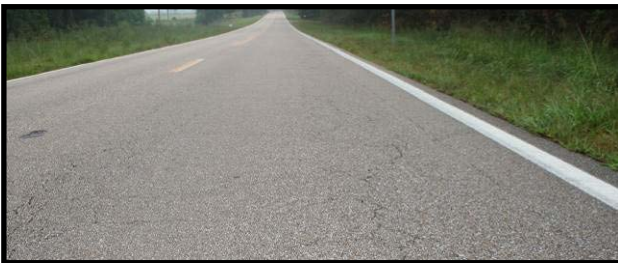
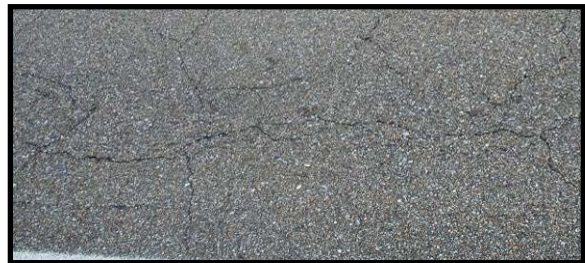
**Figure 5.1. Hwy 44 Section 1 Pre-Sealing Survey (09/19/2011)**

Several cracks  $\approx$  1 m long. Some wheel path fatigue cracking and numerous cracks  $\approx$  1 to 3 mm wide. Pavement appeared somewhat degraded as cores had to be handled carefully.

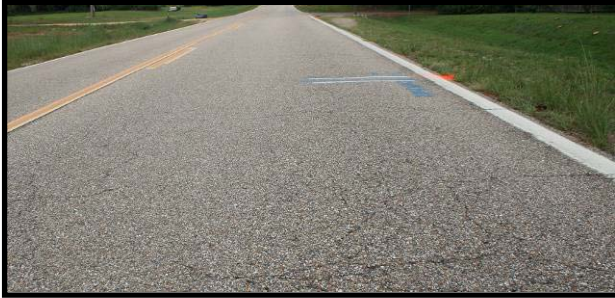
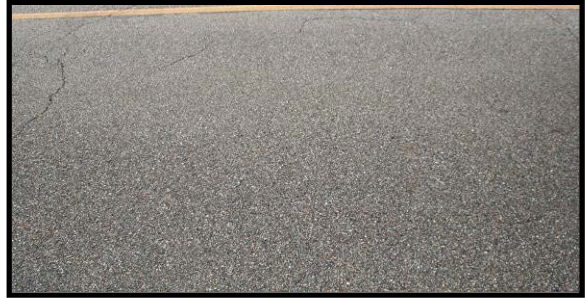
**Figure 5.2. Hwy 44 Section 2 Pre-Sealing Survey (09/19/2011)**

Several cracks  $\approx 1$  m long. Some wheel path fatigue cracking and numerous cracks  $\approx 1$  to 3 mm wide. Similar condition to Section 1.

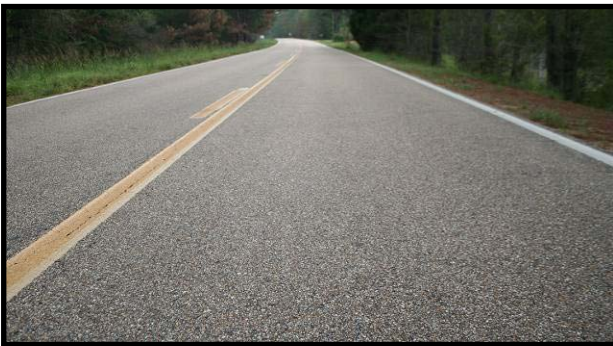
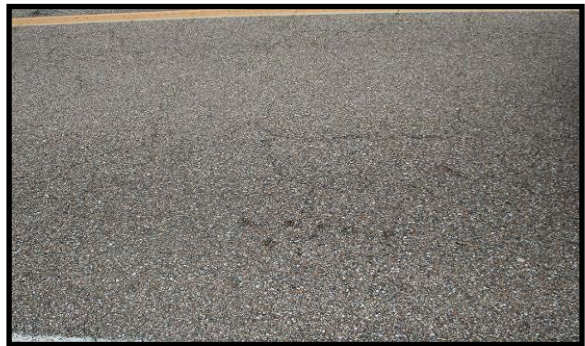
**Figure 5.3. Hwy 44 Section 3 Pre-Sealing Survey (09/19/2011)**

Some cracks, but not as many as sections 1 or 2. Most cracks were evenly spaced and did not cover full pavement width. Typical cracks were 1 to 3 mm wide.

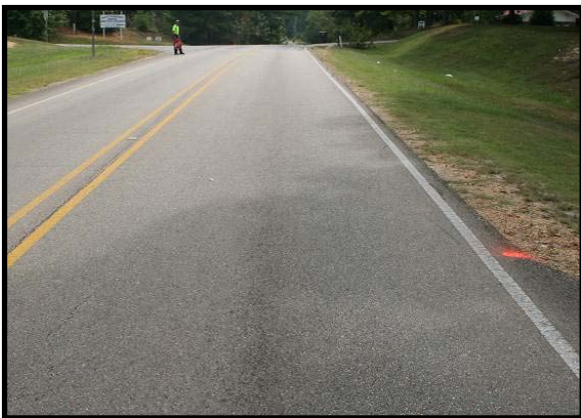
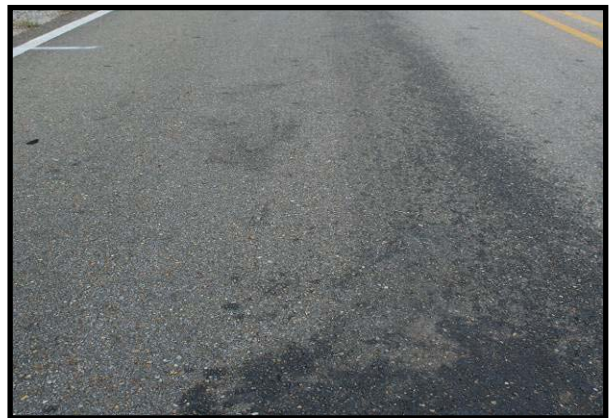
**Figure 5.4. Hwy 366 Section 1 Pre-Sealing Survey (09/10/2010)**

Oil and grease droppings were present in some areas, as well as a small amount of polished aggregate. Cracking was minor.

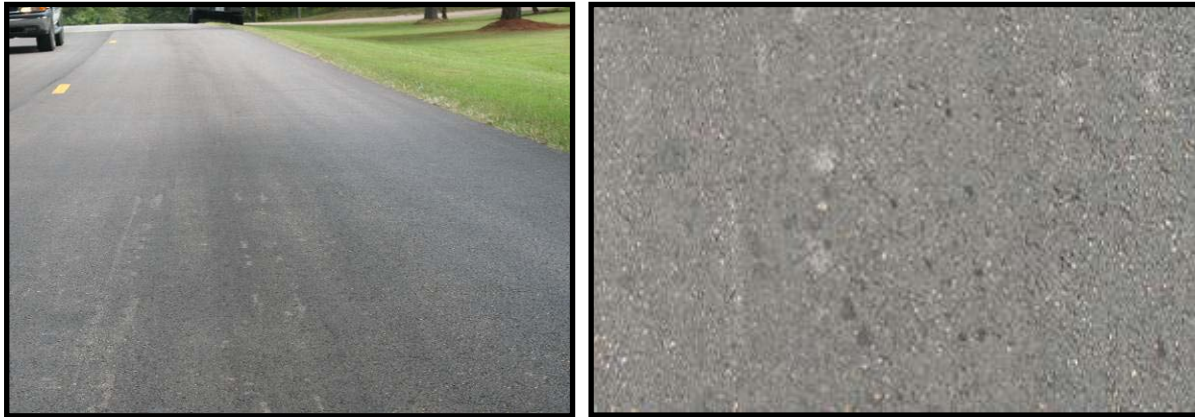
**Figure 5.5. Hwy 366 Section 2 Pre-Sealing Survey (09/10/2010)**

Surface was in good condition. No cracks were observed in the section.

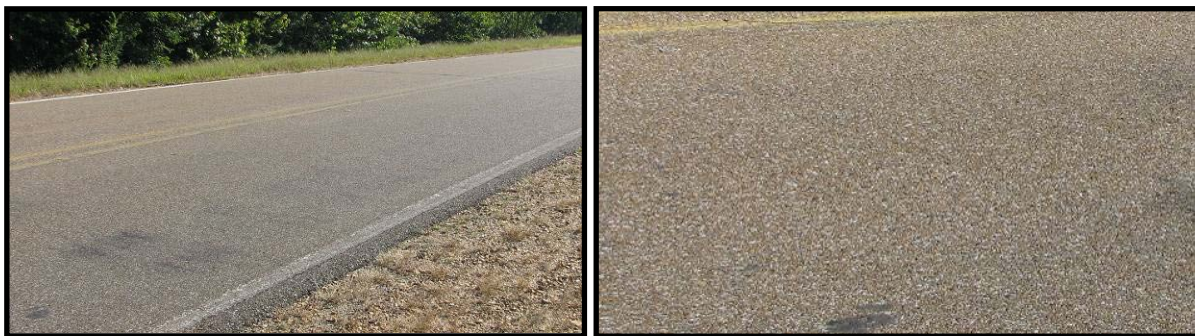
Surface was in fair condition, with exception of large transverse cracks that were avoided when selecting section boundaries. Otherwise the section had some cracks, but was not highly cracked.

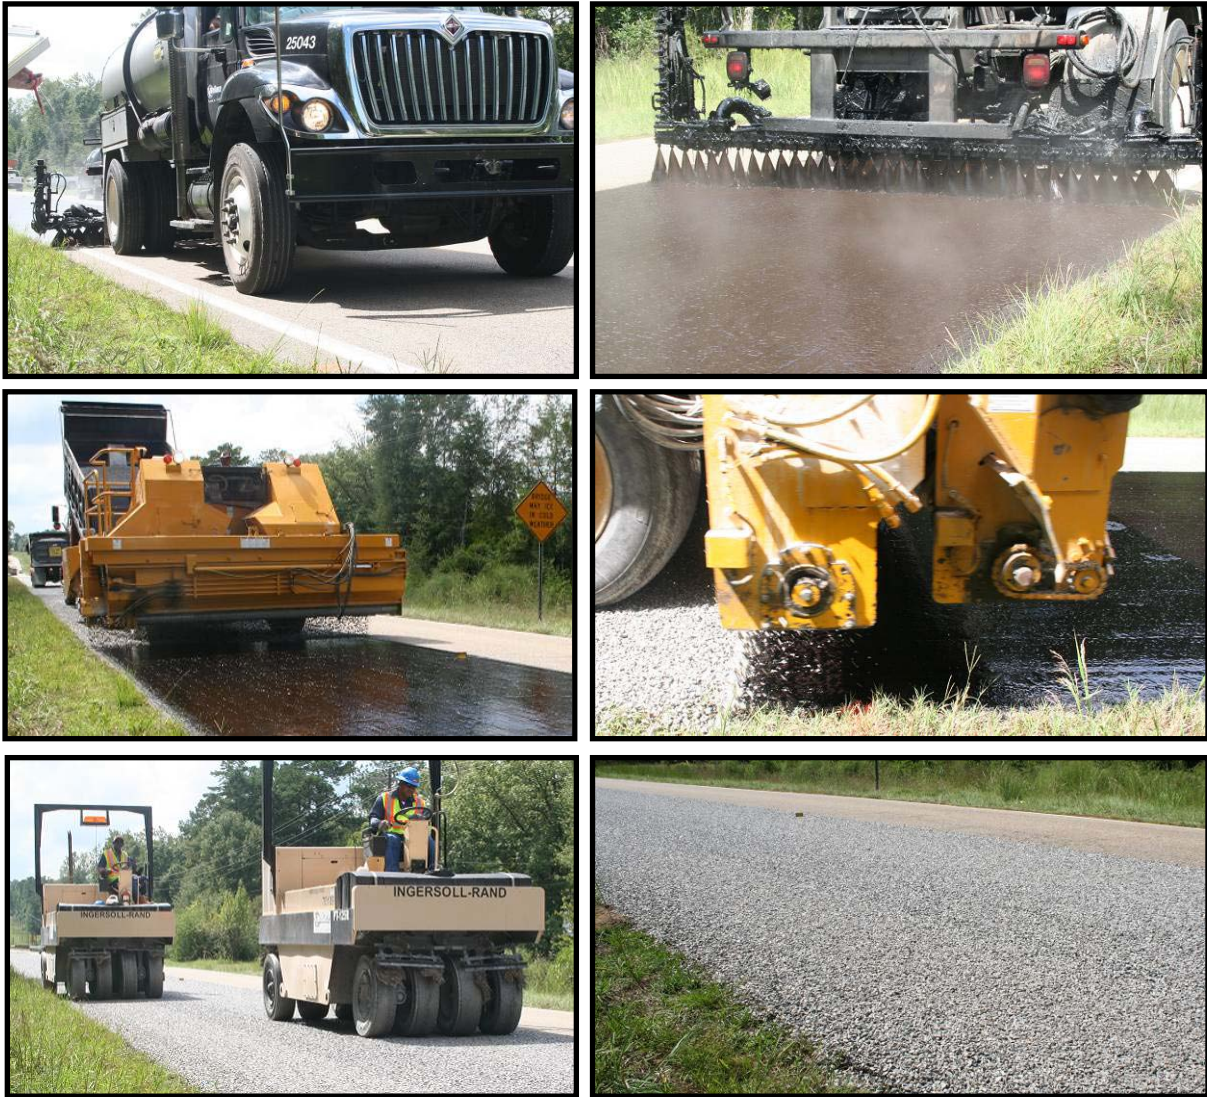
**Figure 5.7. Hwy 44 Chip Seal Application (09/20/2011)**

The Hwy 44 chip seal was placed by TL Wallace Construction, Inc. out of Columbia, MS. At 8 AM on the west end of the project, the relative humidity was 95% and the air temperature was 26 °C. Sealing commenced later in the morning and the three test sections were sealed in the afternoon. Figure 5.7 provides example photographs of the Hwy 44 sealing process.

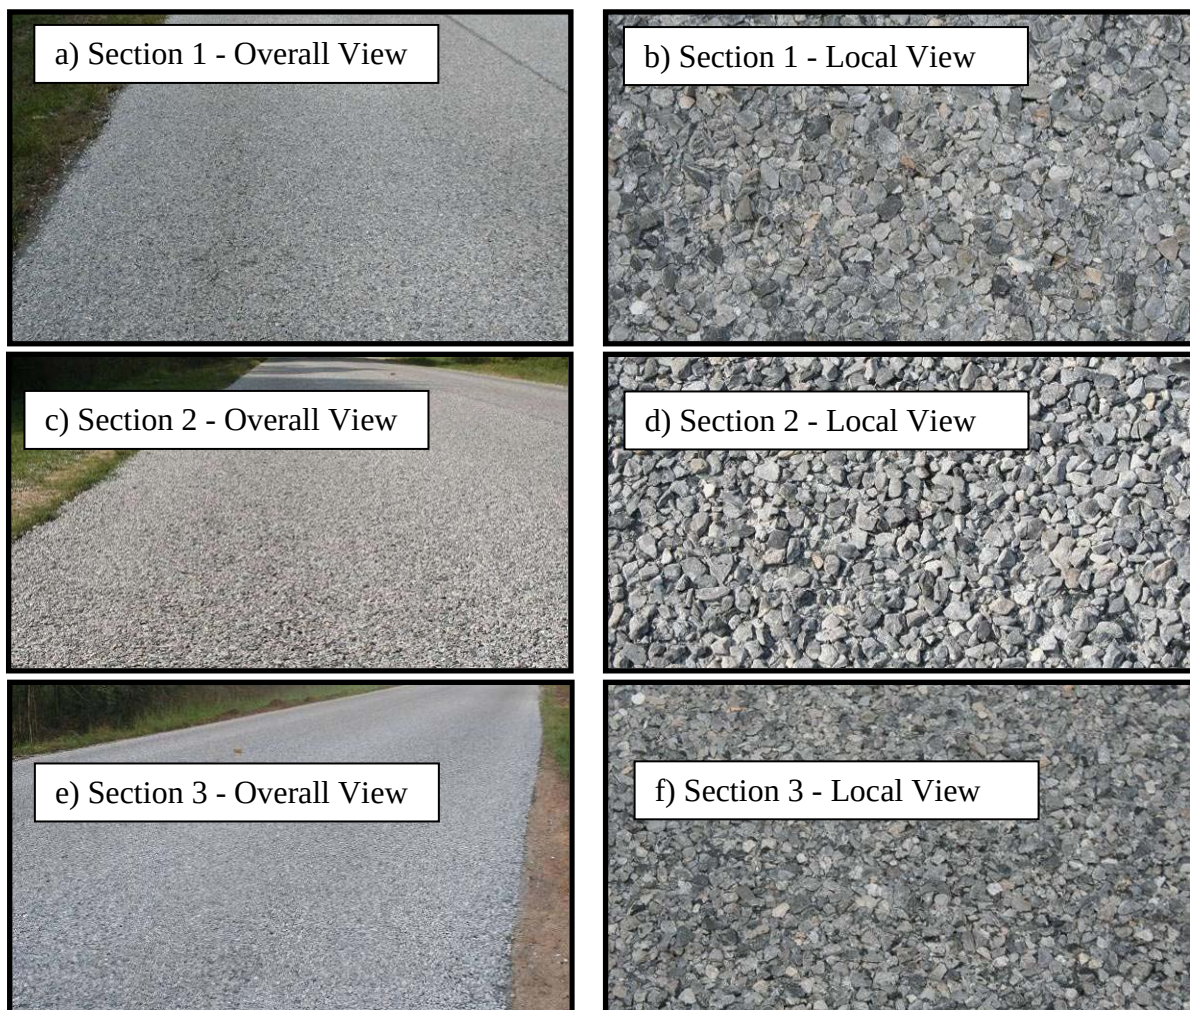
Figure 5.9. Hwy 44 Post-Sealing (09/26/2011)

The seal was in good condition just after placement (Figure 5.9). Aggregate coverage was generally very good. Section 3 had a few areas that were not covered as well as other sections, but these areas were reasonably covered. The seal within a few centimeters of the centerline was not as well covered as the rest of the pavement. Neither Hwy 44 or Hwy 366 sealed the pavement's centerline prior to applying the chip seal. Wood and Olson (2011) state this practice can avoid excessive asphalt absorption at the joint. The centerline joint appeared to be the best in section 2, a little worse in section 1, and the worst in section 3.

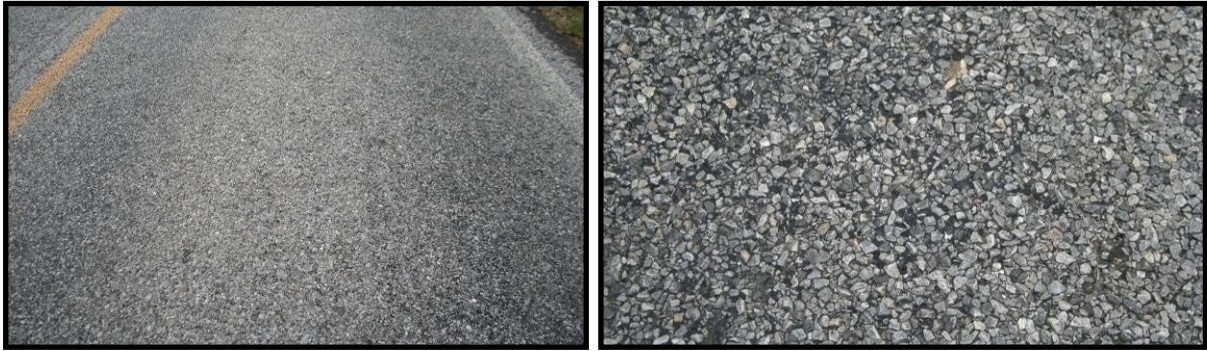
**Figure 5.13. Hwy 44 Section 1 Two Year Survey (09/18/2013)**

There were signs of lack of texture/full embedment in wheel paths, but no meaningful bleeding/flushing. Centerline was in better shape than Section 2. There was some wheel path rutting.

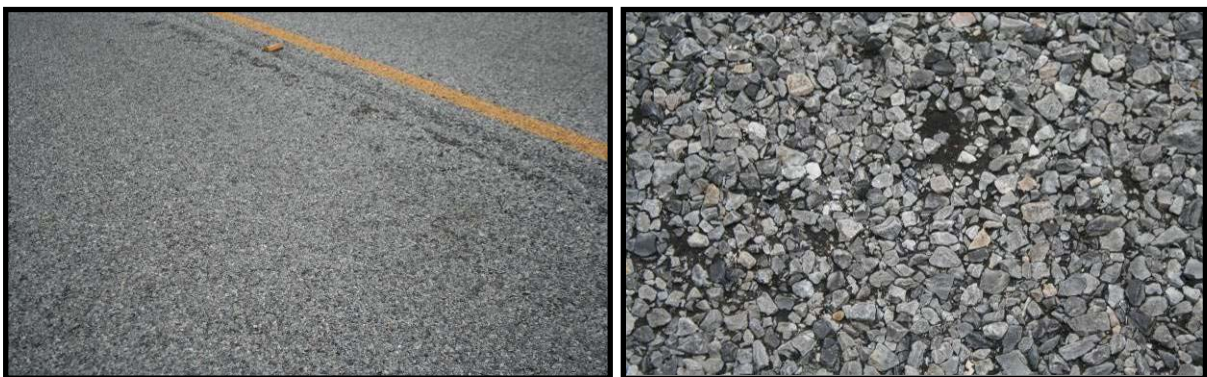
**Figure 5.14. Hwy 44 Section 2 Two Year Survey (09/18/2013)**

Centerline had some noticeable problem areas. Aggregate loss and bleeding were a little worse visually than Section 3, but otherwise the same general observations were made. Seal was in decent shape.

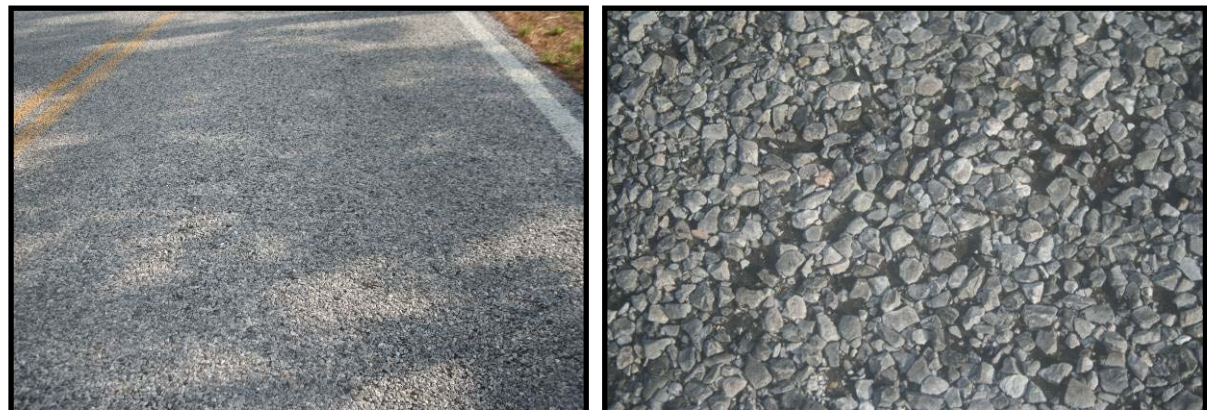
There were noticeable areas where binder was visible; i.e. aggregate loss. Some areas were as large as 2.5 cm diameter. There were no signs of bleeding and overall the condition was about the same as Section 1 even though aggregate loss seemed a little worse than Section 1. Seal was in reasonable shape.

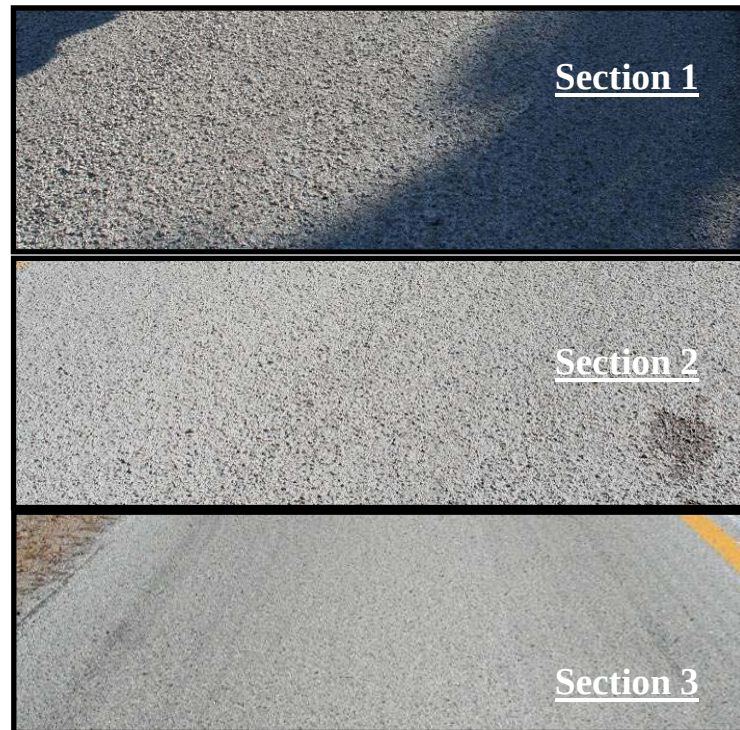
**Figure 5.16. Hwy 366 Post-Sealing Survey (09/24/2010)**

The Hwy 366 seal was in good condition just after placement (Figure 5.16). Two-hundred and eighty-six days later the seal was in reasonable shape (Figures 5.17 to 5.19). No major failures were observed in the test sections. The pavement was plowed for snow three times in the winter of 2010. Approximately two years after placement (736 days), the seal's condition was evaluated again (Figures 5.20 to 5.22). The seal had degraded, but was still in reasonable shape and functional. The winter of 2011 was mild and no snowfall occurred, so there was no additional snow plow activity between the intermediate and two year surveys.

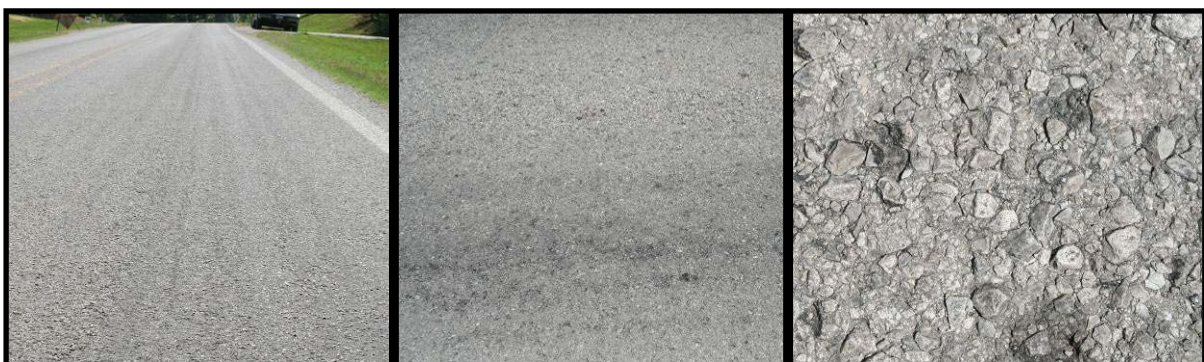
Slight aggregate loss, some popouts, and a little more aggregate loss in the wheel path. Some underlying cracks were beginning to be visible, but overall no major distresses were observed.

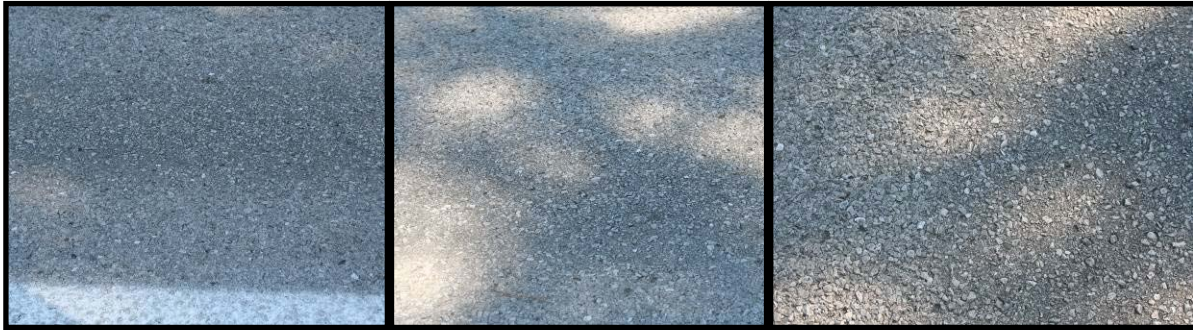
A few popouts. Wheel path was slightly darker than the rest of the pavement, but seal was in very good shape. No cracking observed; seal in a little better shape than Section 1.

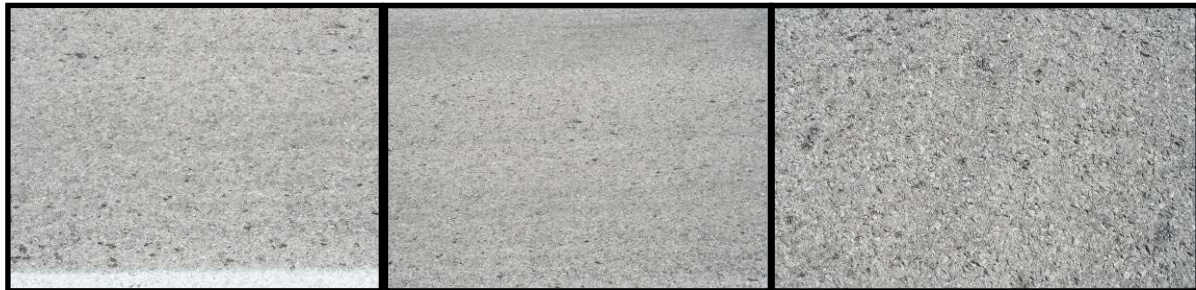
Considerable popouts. Reflective cracks were easily visible. Some longitudinal cracking, but other than the large transverse cracks, there were no major distresses other than excessive binder in a few areas that did not appear to be traffic related.
