Chip and Scrub Seal Field Test Results for *Hwy 17* and *Hwy 35*

Final Report

FHWA/MS-DOT-RD-09-202-Vol II

Mississippi Department
of Transportation

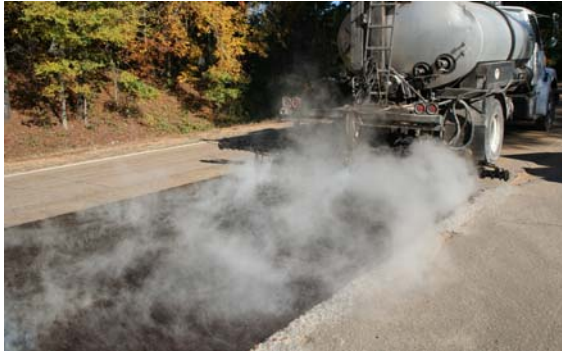
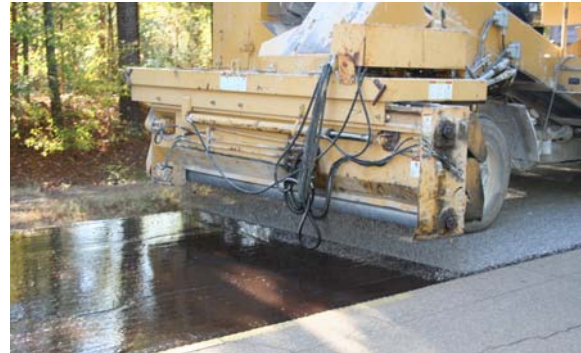
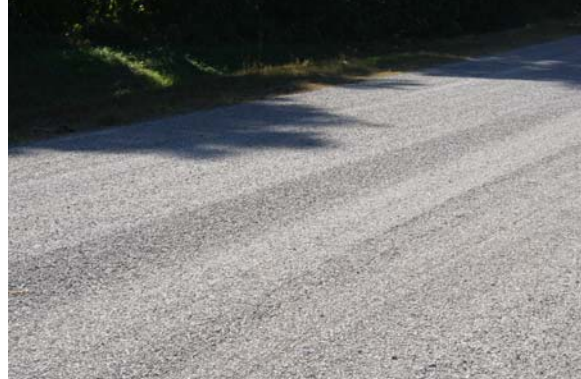
Figure 1.1. Photos of Chip and Scrub Seal Treatments

(a) Chip Seal Emulsion Application-Hwy 17

(b) Covering Emulsion w/ Aggregate-Hwy 17

(c) Scrub Seal Emulsion Application-Hwy 35

(d) Chip or Scrub Seal Completed-Hwy 17

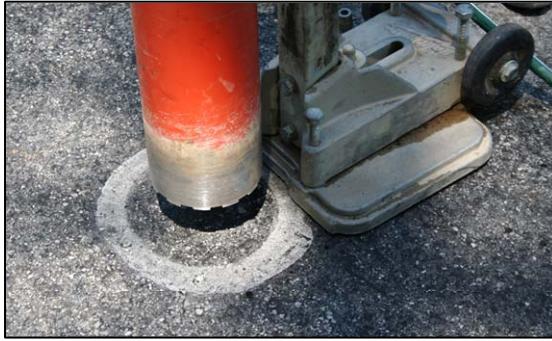
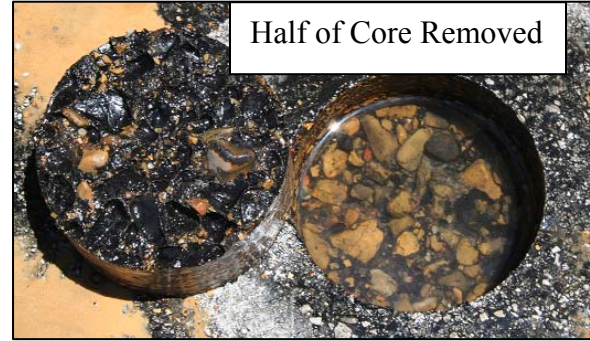
Figure 3.7. Coring of Hwy 17 After Test Phases

provide thickness repeatability measurements. The results of coring are provided in Table 3.4. Note that five of the twelve locations had stripped significantly (Figure 3.7b) and that the core at coordinate 7.251 had a crack through the core.

(a) Coring of FWD Test Location

(b) Example of Stripped Core

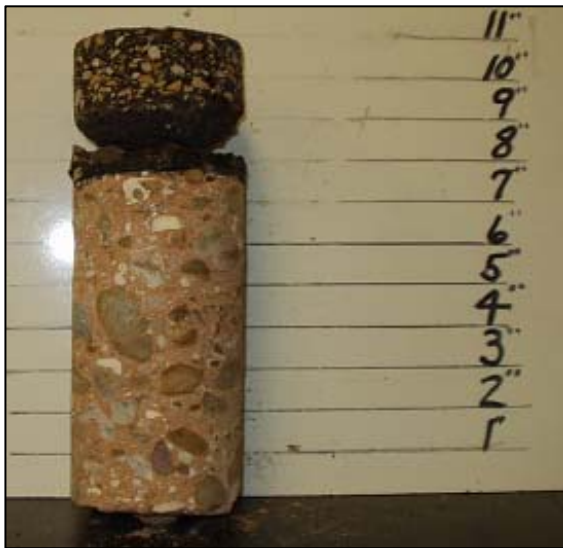
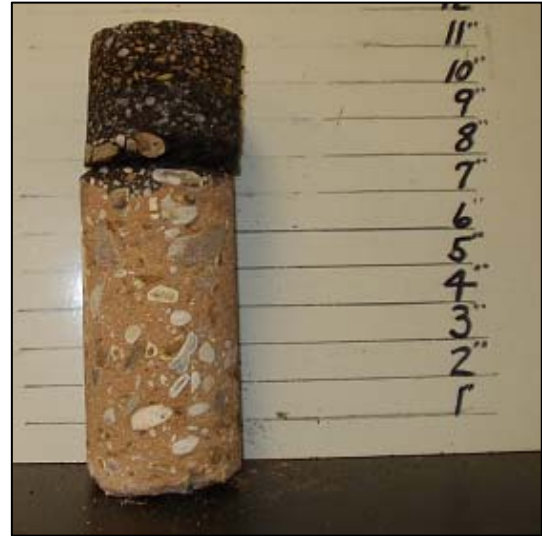
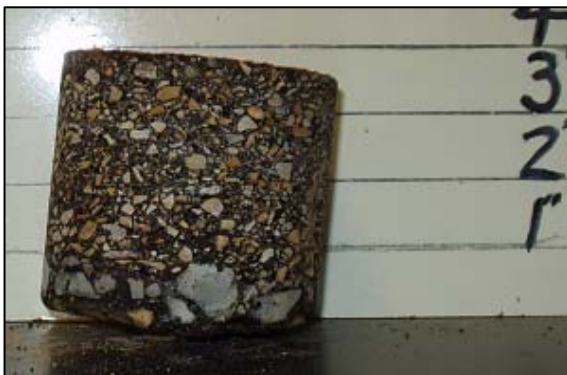
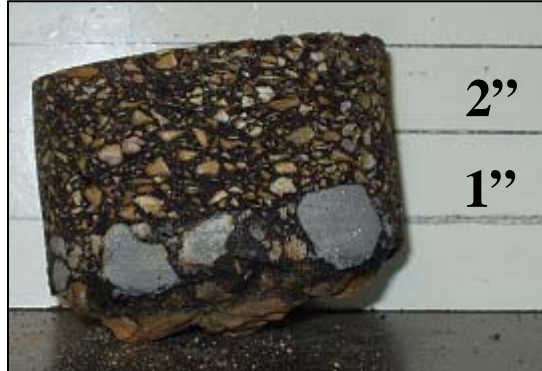
Figure 3.9. Coring Photos of Hwy 35

Coring was performed in sections 3 and 4 prior to the 2005 scrub seal construction. Table 3.5 summarizes the locations of the cores. Figure 3.9 provides photos of the cores and estimates of layer thickness.

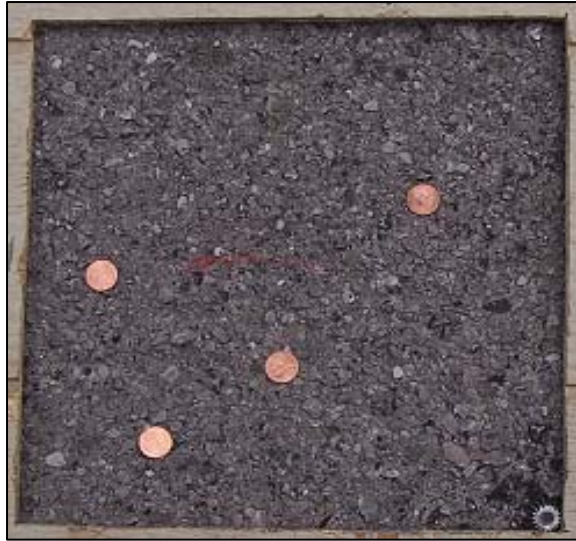
Figure 3.11. Aggregate Retention Testing

A piece of clear Plexiglas was placed over the hole and a transparency with a printed grid with horizontal and vertical spacing of 1.27 cm (0.5 in), or 256 squares, was subsequently placed onto the Plexiglas (the same transparency was used between phases). Some testing did not make use of the Plexiglas or the wooden board, but at least one of these items was present for all testing. The areas where aggregate was lost in a given phase were colored onto the transparency with a permanent marker; a different color was used for each test phase on the same transparency. The operator colored 1/4, 1/2, 3/4, or the entire square.

(a) Original Method (Phase 1)

(b) Final Method (Phases 2 and 3)

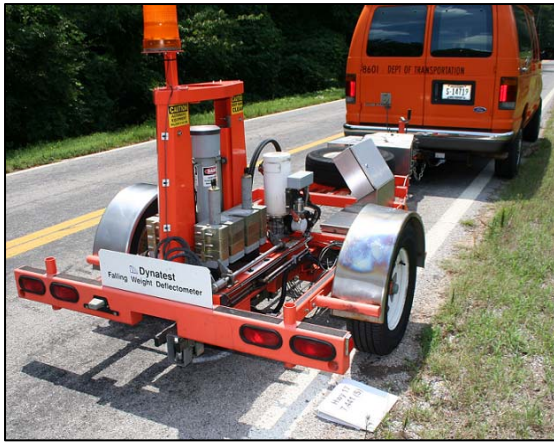
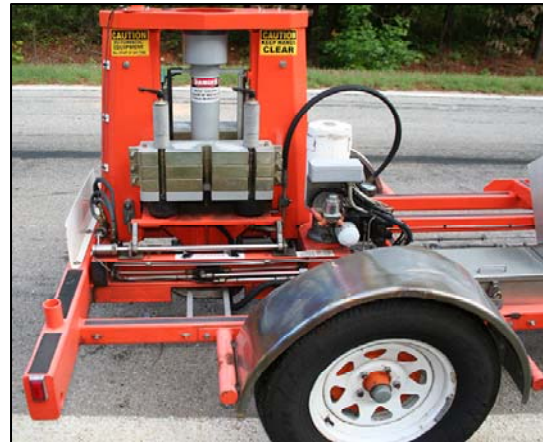
Figure 3.13. Falling Weight Deflectometer Used for Testing

The Falling Weight Deflectometer (*FWD*) used during testing was a *Dynatest® Model 8000*. Figure 3.13 contains photos of the device. The *FWD* works by dropping weights a known distance onto a cushioned load plate resting on the pavement to produce a desired impulse into the pavement. The force applied to the pavement is measured with a load cell and the stress is calculated using the known dimensions of the load plate.

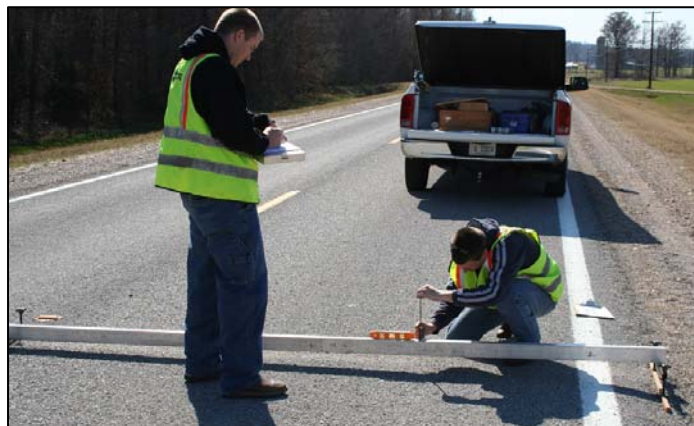
Figure 3.14. Manual Rut Measurements

Manual rut measurements were performed with a metal rut bar as shown in Figure 3.14. A rigid bar with lateral distance markers was leveled and a caliper was used to measure

to the pavement surface at twelve locations across the lane width. Some of the measurements were used for cross slope calculations and the remaining measurements were used to determine the rut depth profile of the lane. These measurements were performed only on *Hwy 35* to provide a baseline measurement for comparison to profiler data, as well as for general information regarding the test sections. Manual rut measurements were not performed on *Hwy 17* due to logistical and traffic control constraints.

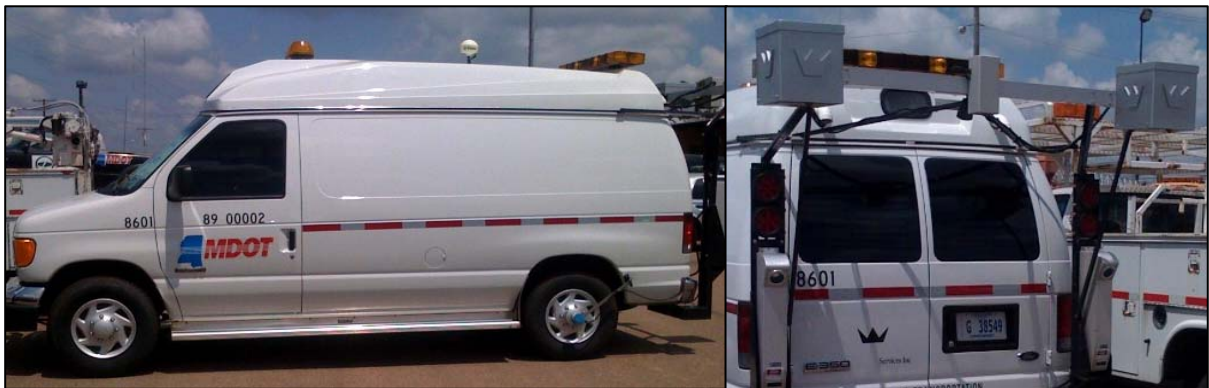
Figure 3.16. Automated Data Collection Vehicle Used for Roadway Profiles

A *Pathway Services Inc.* profiler was used to collect distress data under *Mississippi State Study 173* that was used in this project. A *PathRunner XP* model *LG-23* was used to collect the data. Data was collected in three phases. The data collection vehicle collects the necessary automated road survey data in one pass at normal highway speeds. The vehicle is equipped with cameras, lasers, accelerometers, distance measuring interfaces, global positioning system features, and electronic controls. Data collected for this project were: 1) rut depths (*Rut*), 2) International Roughness Index (*IRI*), 3) Fatigue cracking (C_F) 4) longitudinal cracking (C_L); 5) Transverse cracking (C_T); and 6) Block cracking (C_B). Photos of the *PathRunner XP* can be seen in Figure 3.16.

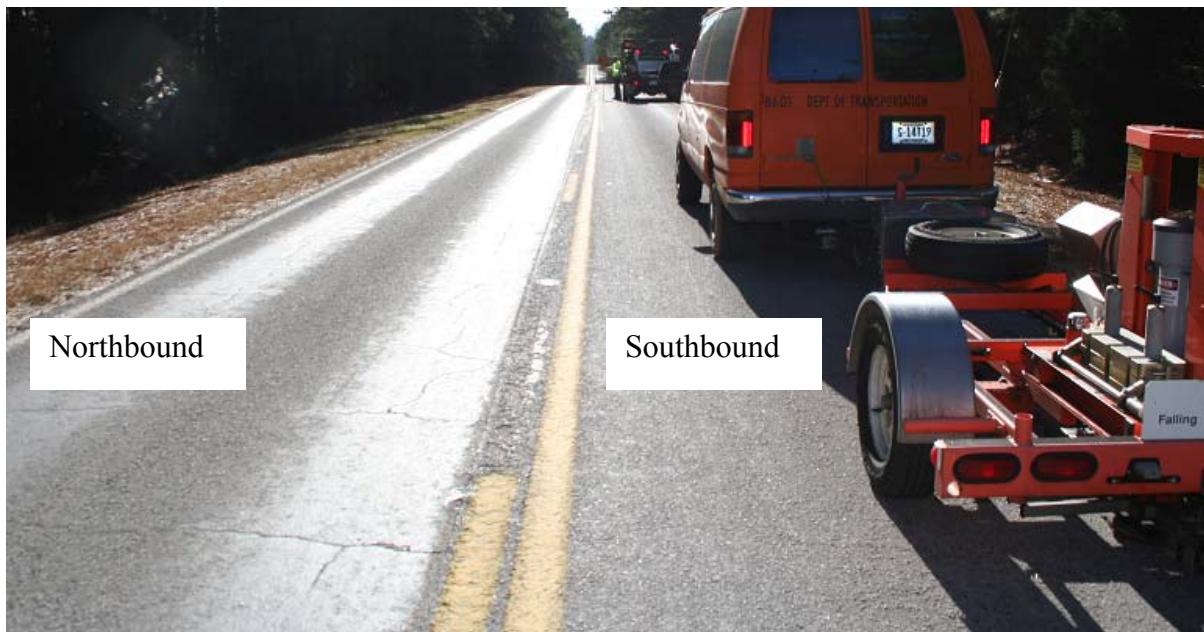
Figure 4.1. Relative Differences in Hwy 17 Wheel Path Aggregate Coverage (Jan 2009)

this behavior. Empty log trucks were frequently traveling southbound, were loaded, and traveled loaded on the northbound lane of the test section. No quantitative data was obtained

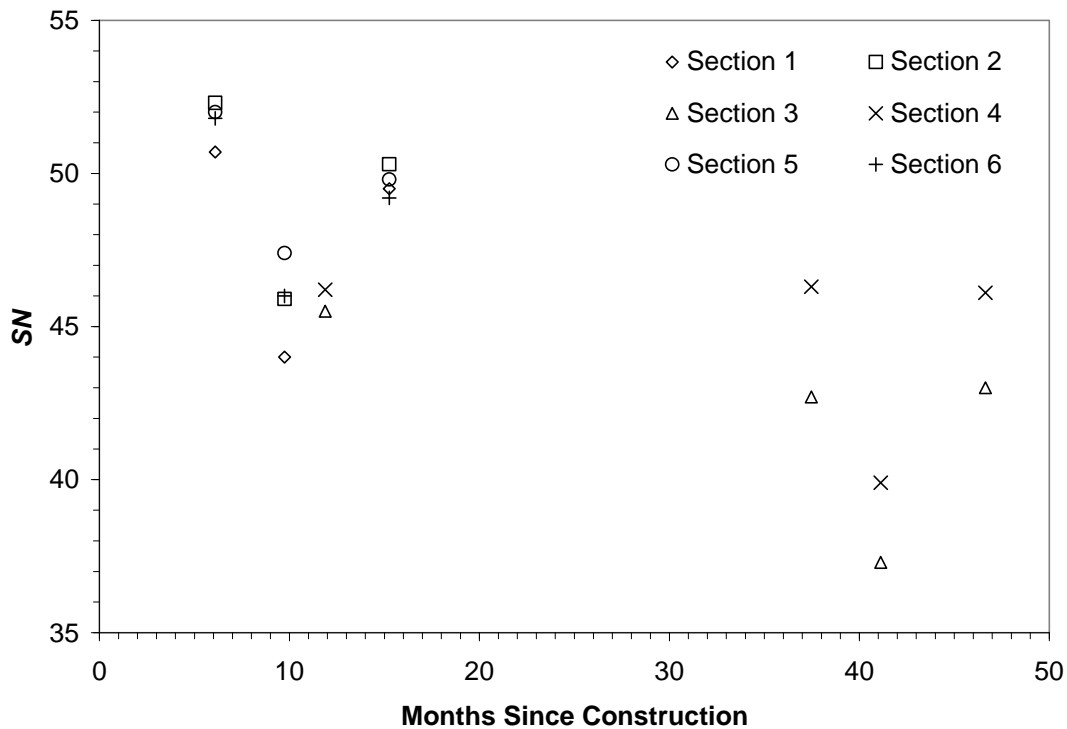
Figure 4.2. Skid Data of Individual Test Sections

The data from the 2007 construction at 9.74 months was taken on the same day as that for the 2005 construction at 41.12 months (note the groups of sections were built 31.41 months apart), which is noteworthy since all this data falls below the trend of the remaining data. The temperature measured by the skid testing equipment is shown in Table 4.5 and shows the temperature on this day of testing was higher than for any other test interval. The temperature could have lowered the readings by livening the binder and thus allowing more flexibility of the cover aggregates, though this is purely speculation since skid data is not adjusted for temperature and no quantifiable data is available to support the statement.

Figure 4.3 plots the average values of all skid data collected. The data is identical to Figure 4.2 with the exception that all data was plotted as one series. The trend line of Figure 4.3 could be used to estimate the time to achieve a given threshold of *SN*. The large amount of scatter in the data coupled with the relatively small number of measurements makes this merely a crude estimate, but it has value when applied in the context of a rough approximation.

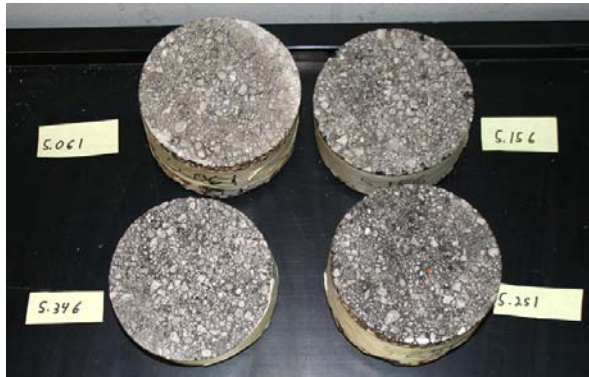
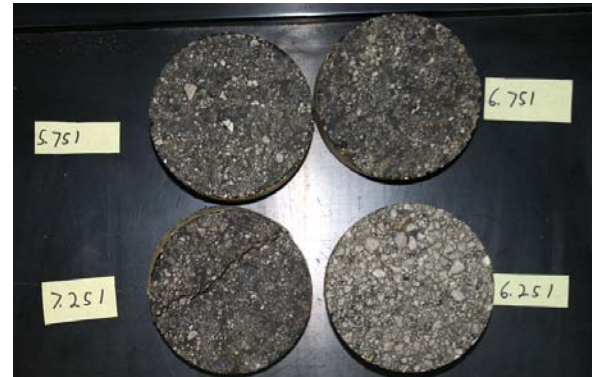
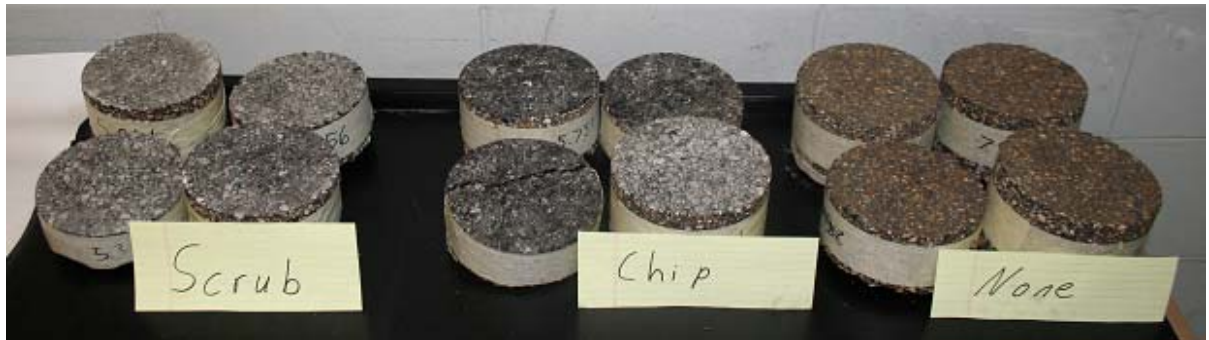
Figure 4.4. Photos of Cores Taken From Northbound Hwy 17

for effective evaluation. The average total aggregate loss of the two chip seal sections was 2.89%, while the average total aggregate loss of the four scrub seal sections was 3.45%. The slightly higher loss of aggregate from the scrub seal sections, though, should be considered in the context that all four scrub seal sections were able to be evaluated while only two of the six chip seal sections were able to be evaluated.
